1st International Conference on Structural Integrity, ICONS-2014

Analysis of Superheater Boiler Tubes Failed through Non-linear Heating

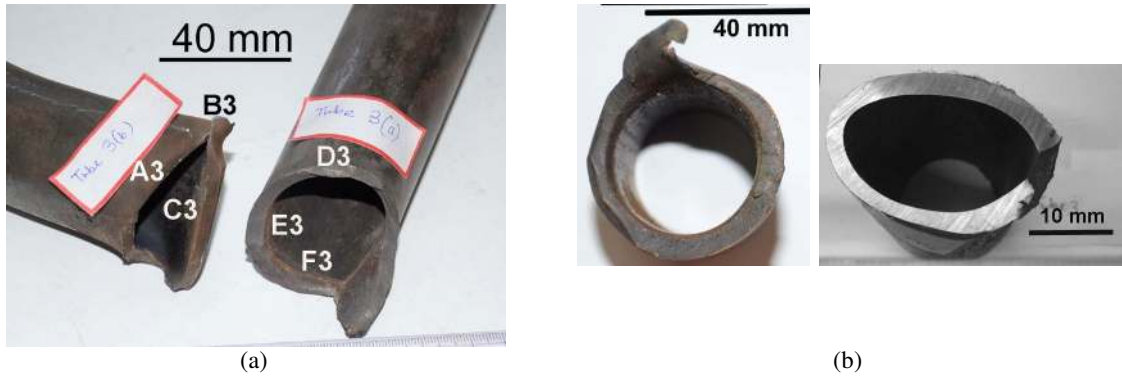
The tube T1 is found to fracture circumferentially (Figs. 1a & b), whereas a square type fish mouth opening of 12 cm long and 12 cm wide along longitudinal direction is observed in tube T2 (Figs. 2a&b). The outer surface wall is locally thinned down at some points. However, there is no material loss at the inner surface wall of the tubes, as shown in the cross-sectional image near the failure (Fig. 1b & 2b). It is interesting to note that the fractured portion of tube T1 is caved inside (C3 in Fig.1a), but tube thickness has no reduction entire the failure region. The changing color near fish mouth opening of tube T2 is the signs of high temperature flue gas interaction, which is described as hot (fire) side. It is also noticed that the T2 is bent towards hot side. The surface deformation might be due to the continuous erosion by flue gases, resulting in crimping and thinning down the outer surface. It is interesting to note that some regions of tube wall are locally thinned down to 0.8-0.3mm (85-95% of wall thickness).

Fig. 1 Failed tube T1 (a) close-up view of fractured portion (b) cross sectional view

thickness and d is tube internal diameter) at the thinnest region is about 2.5 times of UTS value of the steel. It means hoop stress is operative at failed region. Similarly, the hoop stress of tube T2 is near to room temperature yield strength of the material, however, it might be higher than high temperature yielding, resulting in the failure of tube through fish mouth opening.

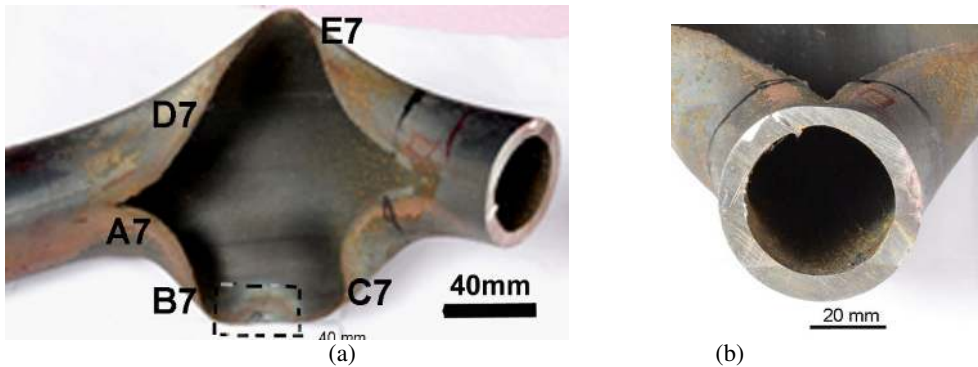
Fig. 2 Fish mouth opening in tube T2 (a) longitudinal (b) cross-sectional

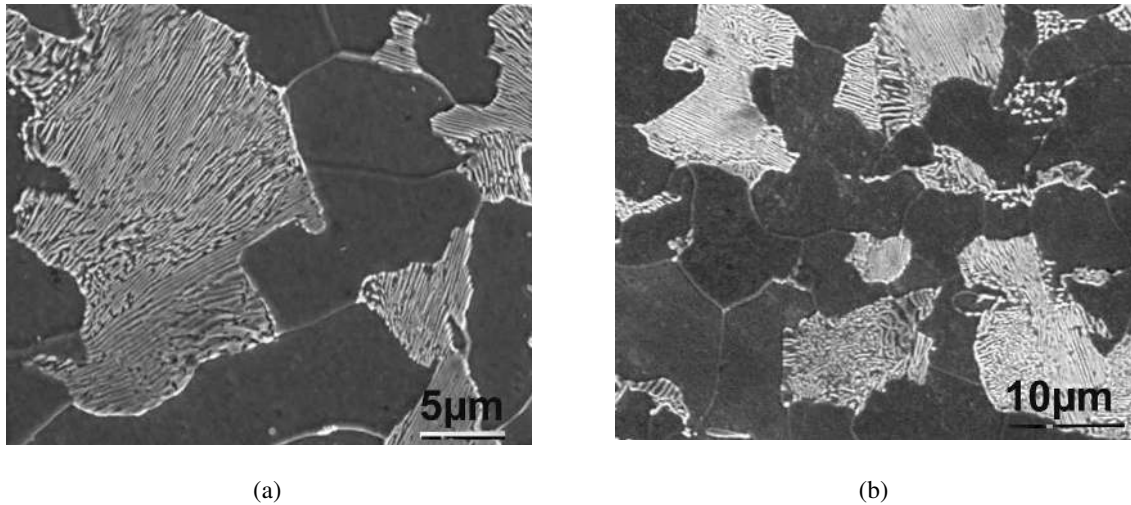
Fig. 3 shows the microstructures of tube T1, comprising ferrite and pearlite colonies. The pearlite and ferrite are distributed similar way in both near failure and away from failure regions.

Fig. 3 SEM images of tube T1 at (a) away from failure, (b) near failure

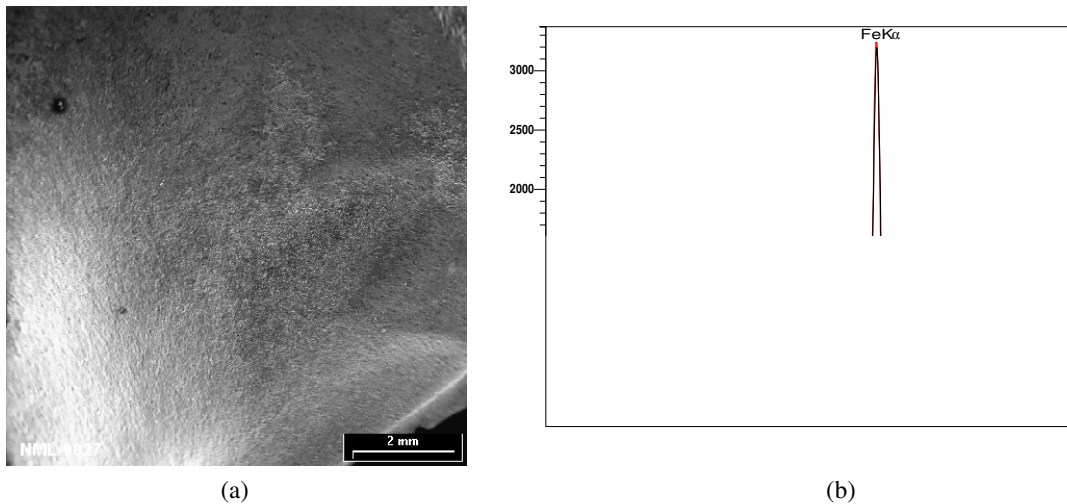
Simultaneously, the thinnest failure region (B3 of Fig. 1a) is explained as rough region with the presence of fused particles due to coal-ash/fly-ash corrosion and erosion through flue gas (Fig. 4a). It results in localized thinning. The particles are K and Ca based alkali compounds along with some Ti and silica, as confirmed through EDS analysis (Fig. 4b).

Fig. 4: (a) SEM image of the corroded/eroded area of B3 region (as shown in fig. 1a) in tube T1 and (b) EDS qualitative analysis of surface shown in Fig. 4a

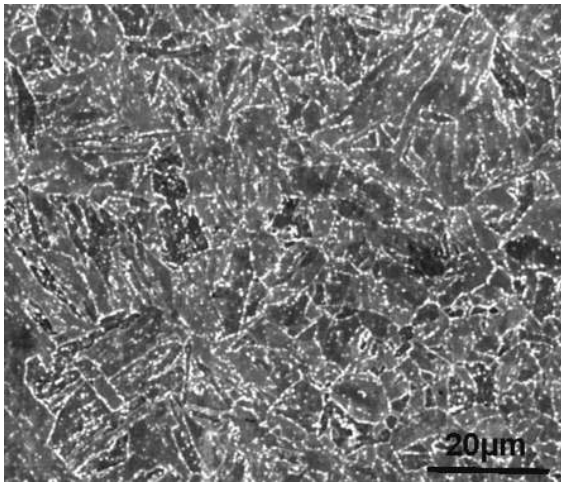
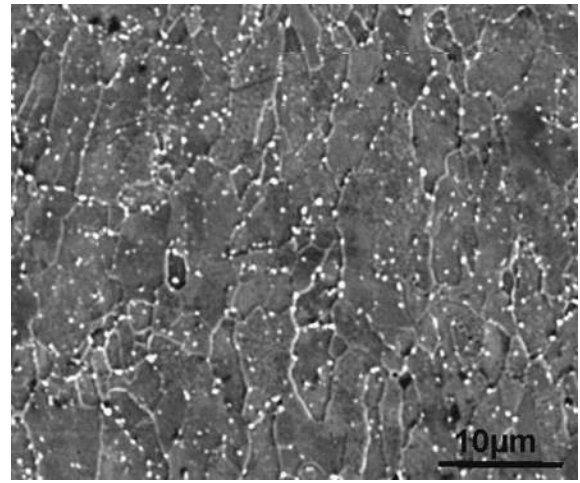
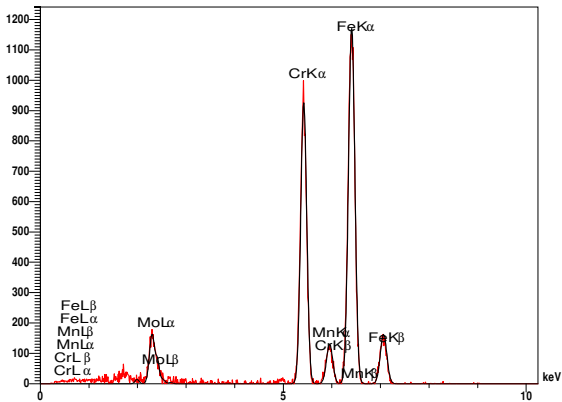
Unlike T1, the microstructure of tube T2 consists of tempered martensite and fine carbides at both away and near failure sites (Figs. 5a & 5b). This microstructural changes are due to the effects of Cr and Mo elements in this steel. A large number of fine carbides have been found in the matrix, which are mostly (Cr, Mo) carbide, as explained in EDS analysis of failure region (Fig. 5c).

Fig. 5: SEM images of tube T2 showing the regions: (a) away from failure, (b) near failure, (c) EDS analysis of Fig. 5b

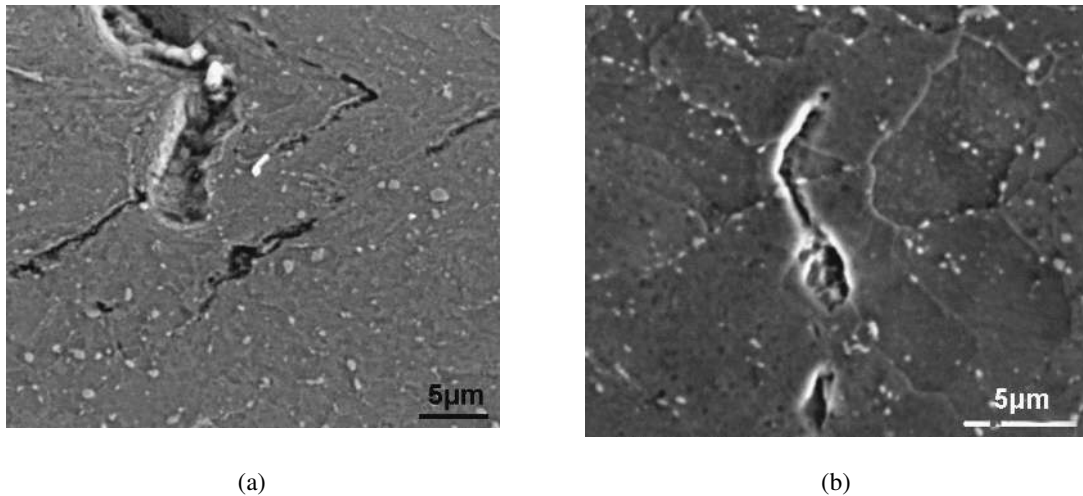
Fig. 6 shows the SEM image at the cross sectional area of thin edge (shown as dotted line in Fig. 2a) near failure region of tube T2. A large nos. of voids and cracks has been found at the grain boundaries, and the cracks are propagated through the grain boundaries (Figs. 6 a&b). Moreover, the carbide particles are coarsened in the matrix and grain boundary. The generation of cracks and voids near the thin edge is related to sudden rise of temperature at the failure zone. The non-linear temperature gradient, i.e., the non-uniform temperature distribution, is one of the main reasons for sudden temperature rising in the tubes, preventing normal heat pick up along the complete length of tube from inlet to outlet. Simultaneously, the outer surface thinning of tube- T2 occurs owing to the continuous erosion through flue gases. It is evidenced by thickness reduction of tube T2, but no internal material loss, as shown in Fig. 2b. Similar type of outer surface thinning has also been observed in tube-T1 at very small region (B3 of Fig.1a) which confirms the presence of silicide and oxide particles through EDS analysis. The surface thinning is also related to the hoop stress generation.

Fig. 6 SEM image of cross sectional area of thin edge region of tube T2 near fracture showing (a) some voids and (b) crack propagation.

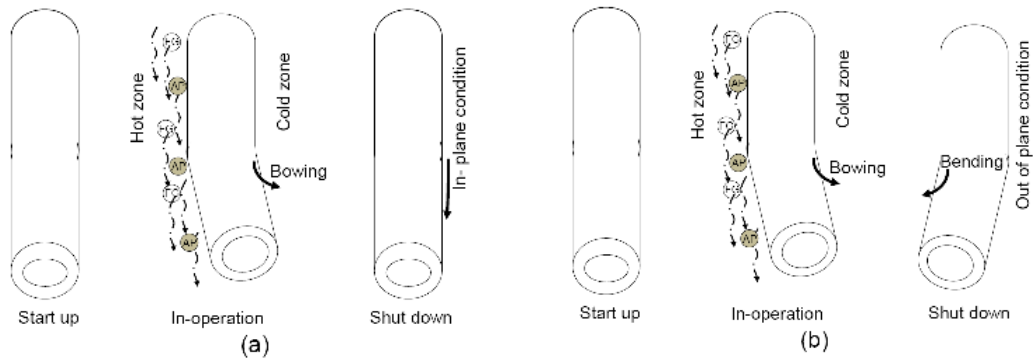
Fig.7 Tube conditions during start-up, in operation and shut down steps causing (a) in-plane distortion for linear heating, and (b) out of plane distortion in case of non-linear heating (FG: flue gas, AP: ash particles)

Certain coals contain constituents which form ash deposits that are molten at typical operating temperatures and can cause extensive corrosion. Therefore, periodical checking and removing of coal ash deposit from the tubes and the use of better quality coal are recommended to reduce such kind of failure. Moreover, the startup procedure is a consequence of gradual heating of tube for restricting the flue gas temperature and preventing the sudden water evaporation. The start up and shutdown procedure should be properly followed so that the non-linear heating does not take place, preventing the catastrophic failure within a short life time.
